STERLING PARK SOUTH TOWNHOUSE ASSOCIATION Infrastructure Committee

A Summary of the 8/25/2010 Report to the Board of Directors

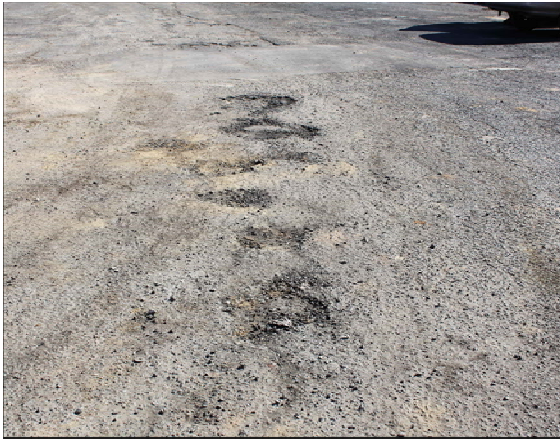
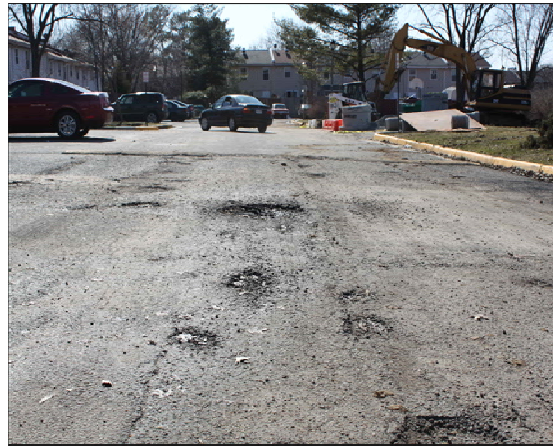
Examples of Asphalt Deterioration:

The asphalt pavement was in generally poor condition. Severe distress (in the form of interconnected cracking, or alligatoring) was noted in numerous locations. Interconnected cracking constitutes broken pavement, the pieces of which will eventually dislodge, forming potholes. Such potholes were also evident in a number of areas.

The asphalt pavement has reached the end of its serviceable life. The severity of the distress would also preclude overlayment as a rehabilitative strategy and full-depth reconstruction is probably necessary. Given that overlayment is not practicable, additional damage would not affect the cost of rehabilitation; therefore that work could be deferred for a few years. It should be noted that some interim repairs (such as filling potholes) would be necessary to limit potential for personal injury and vehicle damage.

The asphalt pavement should be completely removed and replaced. The design profile would depend upon such factors as soil bearing and drainage properties, wheel loads, etc. Accordingly, the services of a qualified engineer (such as ETC) should be retained to better evaluate existing conditions and develop an appropriate design. If replacement is deferred, conditions that could be potentially hazardous or damaging (such as potholes) should be corrected.

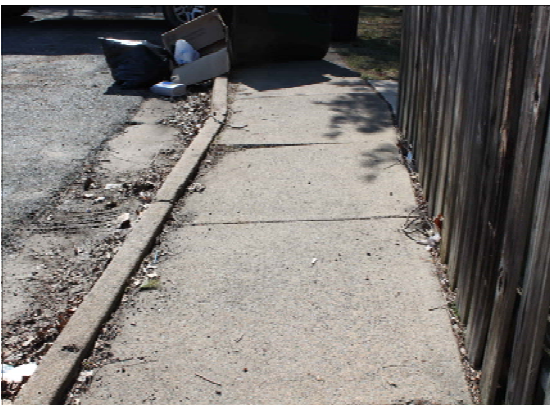
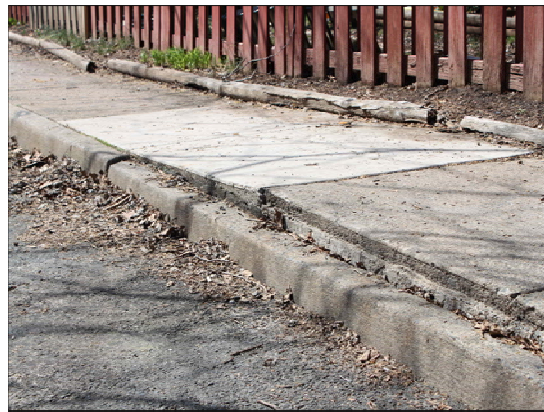
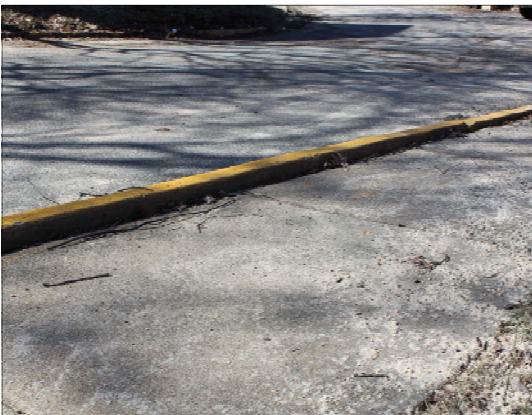
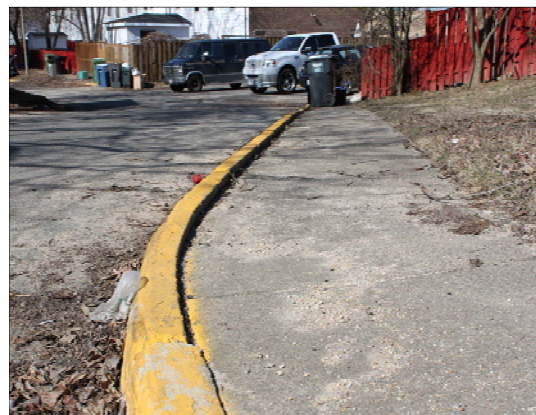
Examples of Sidewalk Displacement & Trip Hazards
